## **URGENT Field Safety Notice**

### **Philips Azurion and Allura Systems**

Potential loss of imaging functionality (Allura/Azurion), loss of motorized movement (Allura), or loss of data (Allura) due to aging Hard Disk Drives

30-APR-2026

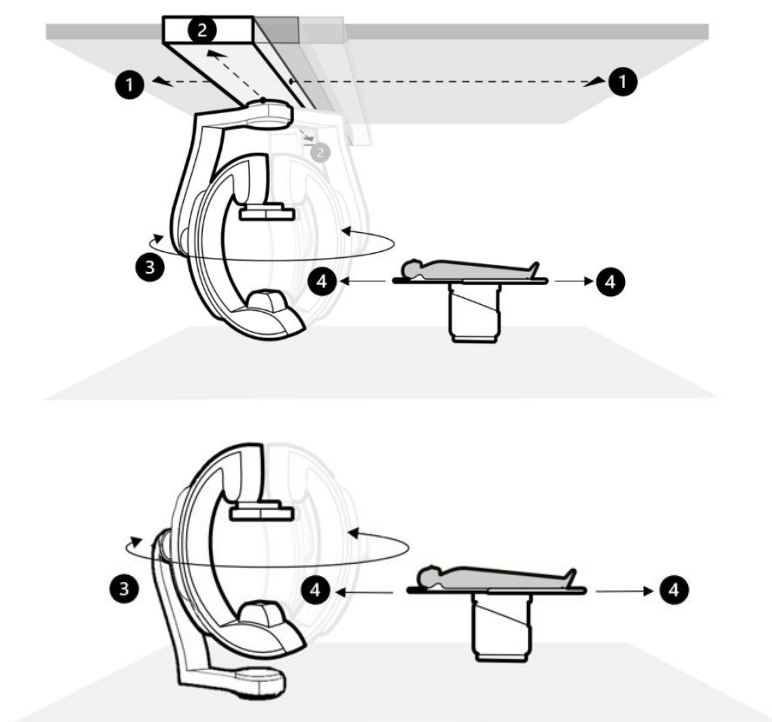
Figure 1 – Manual movements of the ceiling-mounted system (top) and floor-mounted system (bottom)

- Circulate this Urgent Field Safety Notice to all users of the system so that they are aware of the issue and follow the instructions below.
- In case motorized movements are unavailable, the stand can be manually repositioned using the handgrips and brake controls located on both sides of the stand. For ceiling-mounted systems, manual longitudinal (1), transversal (2) and rotational (3) stand movements remain available. Note: Transversal stand movements (2) are only available for ceiling-mounted systems with the FlexMove option. For floor-mounted systems, only rotational (3) stand movements remain available. The table longitudinal position (4) can be adjusted manually, when the table is not tilted (see Figure 1 below).

Philips will replace the HDDs in all affected systems. Philips expects to start replacing the HDDs in September 2026. A local Philips representative will contact you to schedule a visit to replace the HDDs in your system.

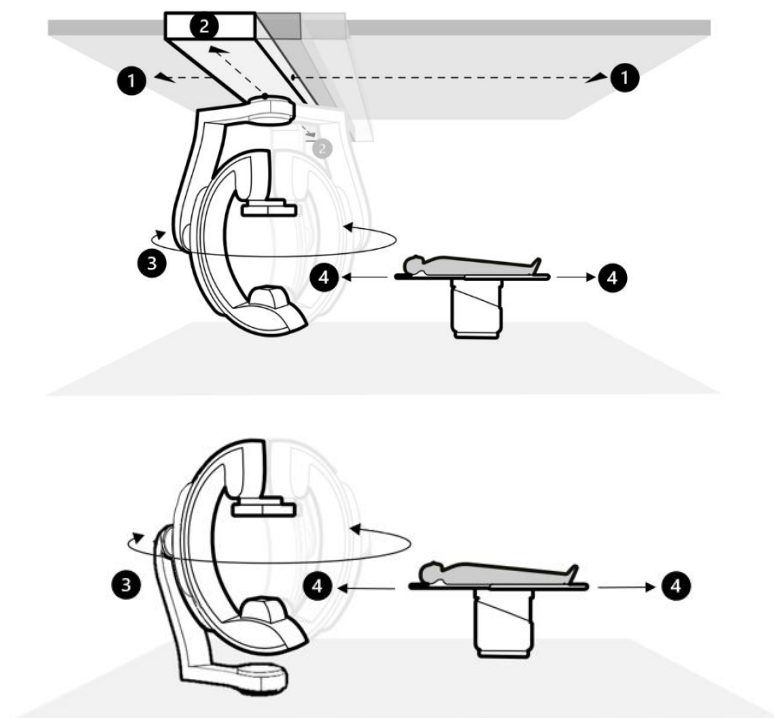
Figure 1 – Manual movements of the ceiling-mounted system (top) and floor-mounted system (bottom)

- Circulate this Urgent Field Safety Notice to all users of the system so that they are aware of the issue and follow the instructions below.
- In case motorized movements are unavailable, the stand can be manually repositioned using the handgrips and brake controls located on both sides of the stand. For ceiling-mounted systems, manual longitudinal (1), transversal (2) and rotational (3) stand movements remain available. Note: Transversal stand movements (2) are only available for ceiling-mounted systems with the FlexMove option. For floor-mounted systems, only rotational (3) stand movements remain available. The table longitudinal position (4) can be adjusted manually, when the table is not tilted (see Figure 1 below).
