Welch Allyn, Inc. 4341 State Street Road Skaneateles Falls, NY 13153 USA	<b>URGENT: Field Safety Notice</b>	2021-07-001-MKE-005
---	------------------------------------	---------------------

ELI280, MLBUR280 and BUR280 Electrocardiographs

ELI280 resting electrocardiograph - Patient mismatch/Software Upgrade

**FSCA-identifier:** 2021-07-001-MKE-005

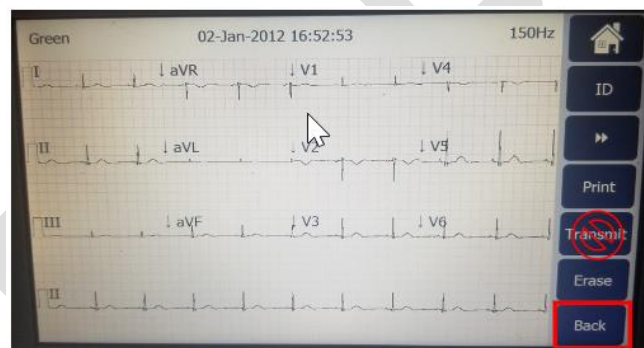
Figure.1

1. An ECG is acquired for Patient A and stored to the cardiograph.
2. An ECG is acquired for Patient B and stored to the cardiograph.
3. The ECG record associated with Patient A is retrieved from memory and any Patient Demographic information is edited.
4. After editing, the "Resting ECG" screen is presented as shown below. Figure 1
5. Pressing the TRANSMIT button from this screen (following any Patient Demographic edit) will transmit an ECG record other than for patient A. (see figure 2, which shows the Resting ECG screen).

If an ECG record is retrieved from the patient directory for a Patient Demographic edit to be performed, once the information has been edited and the screen above (Fig 1) is presented, do not press the transmit button. Instead, press the BACK button which will SAVE the changes to memory and present the user with the following screen, where the SYNC button can be used to transmit the desired record to the configured destination.

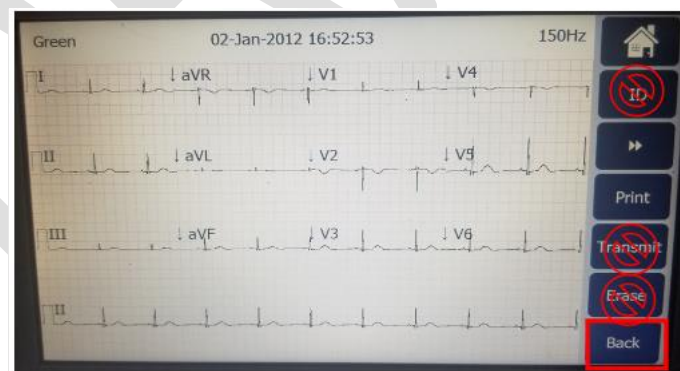
Figure.3

1. An ECG is acquired for Patient A and stored to the cardiograph.
2. An ECG is acquired for Patient B and stored to the cardiograph.
3. The ECG record associated with Patient A is retrieved from memory and ID information is edited.
4. After editing, the “Resting ECG” screen is presented as shown in Figure 3.
5. The user decides to make another ID Edit without leaving the “Resting ECG” screen and presses the “ID” button - Figure 3.

6. After the second edit is performed, the “Resting ECG” screen is once again presented as shown above.
7. Pressing the TRANSMIT button from this screen (following two ID edits in a row as defined above) will transmit an ECG record with the patient demographics

from Patient A and the ECG record for Patient B, this “hybrid” record is then stored in the cardiograph as second record with patient A demographics, and Patient B will no longer be listed in the directory.
