01 November 2021

Urgent Medical Device Correction QIAcube® Connect MDx Instrument REF 9003070

QIAcube Connect MDx User Screen Issue – October 2021

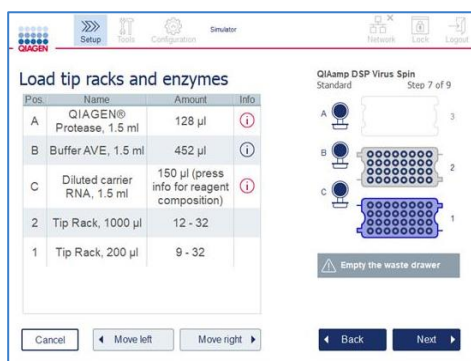
Figure 1 – Run Set-Up Screen

The issue relates to information given during run set-up, which is intended to guide the user on the volumes of reagents to be added to the tube. During the “Load tip racks and enzymes” step of the run set-up, users have the option to access more detailed information by clicking the **Info** button

as shown in Figure 1. The screen then switches to a similar screen, as shown in Figure 2, containing the information that a **minimum volume** is to be added instead of the exact volume as detailed in Figure 1.

1. Follow instructions in the run set-up menu initial screen (Figure 1) and ensure that the volume detailed within the run set-up screen is adhered to using an actual volume only.
2. Upgrade to the latest version of the protocol which is due for release by 01 December 2021 and will be available at www.qiagen.com in the the QIAcube Connect MDx instrument product page. Apart from correcting the protocol text, no other changes to the protocol will be implemented.
3. Complete the Acknowledgement of Receipt form attached in this letter and return it to QIAGEN ASAP.

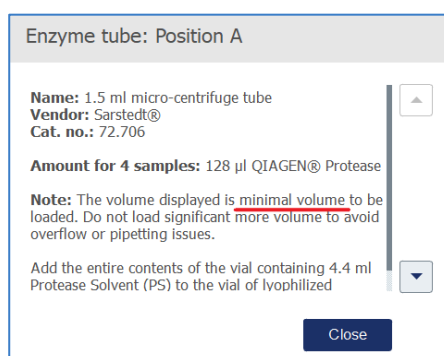
Figure 2 – Screen display after pressing

While the actual amount indicated is accurate, the additional information provided in the Note section does not clearly state that this volume should be exactly loaded onto the instrument.

If a user misunderstands the guidance on the info screen (Figure 2) and pipettes more than the recommended volume detailed on the run set-up screen (Figure 1), it is possible that the tubes will then contain either too much or not enough reagent. This could lead to an over diluted, under diluted, or improperly lysed sample, which in turn would affect downstream processing, leading to a false negative or false positive result, should it not be realized that there has been an issue with sample preparation process.

QIAGEN have assessed the risk of the issue occurring during routine use of the affected protocol and have determined that this notification should be provided to all customers to ensure that they are informed to follow the information given on the screen in Figure 1 and to ignore the statement of the 'minimal volume' on screen 2. Once the customer is aware of the issue, it would be a suitable mitigation to avoid the risks highlighted within this communication.
