## **URGENT Field Safety Notice**

### **Philips Azurion and Allura Systems**

Potential loss of imaging functionality resulting from no or intermittent X-ray radiation initiation through the wired foot switch.

26-FEB-2026

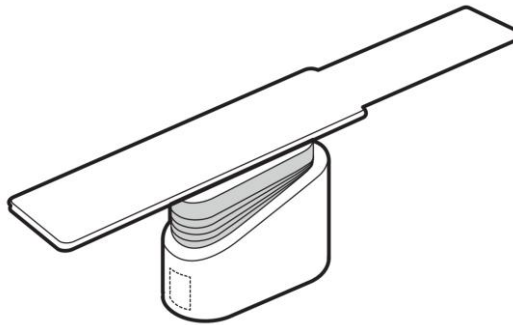
Figure 2 – Table Identification Label

The table below provides information to identify the table type. The identification label of the table is located at the table base (see Figure 2).

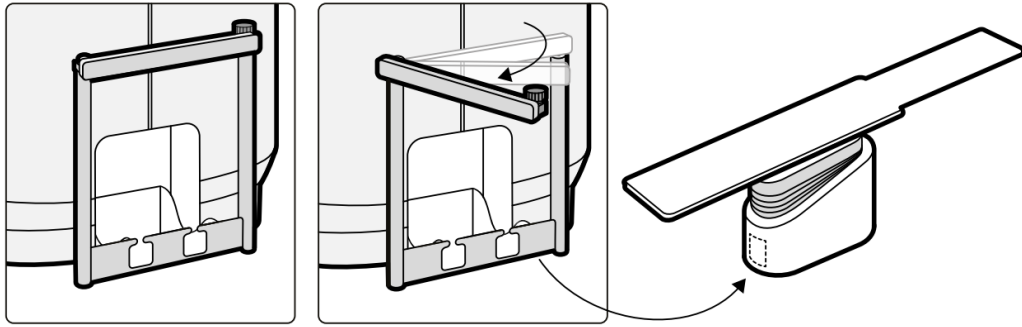
*Figure 3 - Table base accessory rail*

\*To identify if the AD7XT or AD7XNT has the optional table base accessory rail, check the base of the table as shown in Figure 3.
